## Tests of fire suppression effectiveness of damaged water mist systems

DRDC-RDDC-2014-C70  
May 2014

### SP Technical Research Institute of Sweden

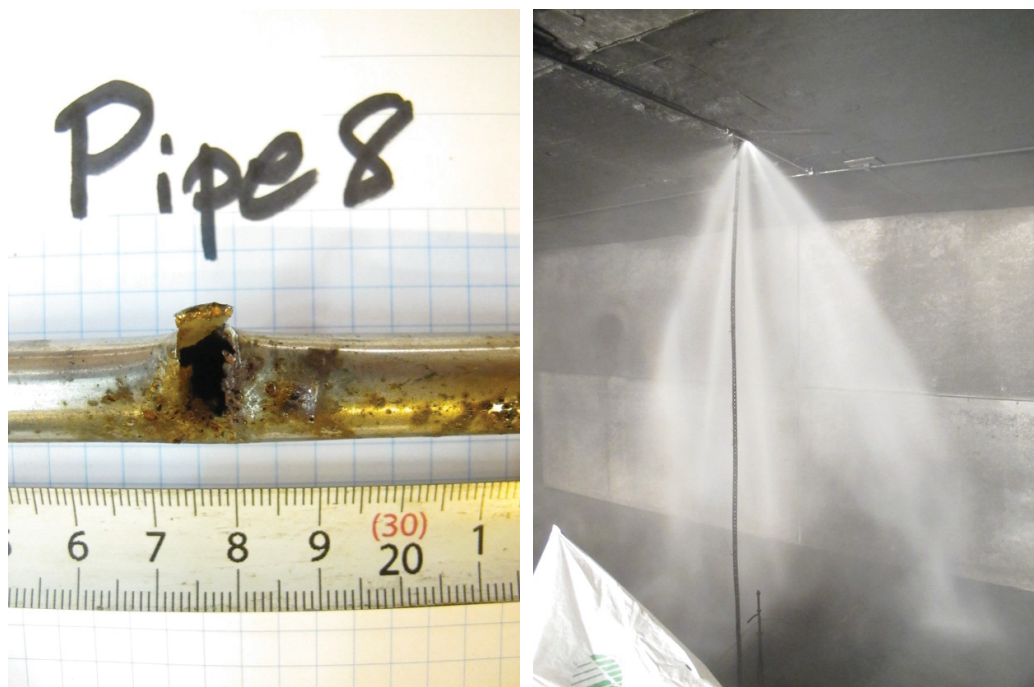
Figure 63. Picture of pipe 8, puncture approx. (not measured yet). To the right is a picture of the spray from the punctures when the pipe is installed in the test compartment. The pipe diameter is 12 mm

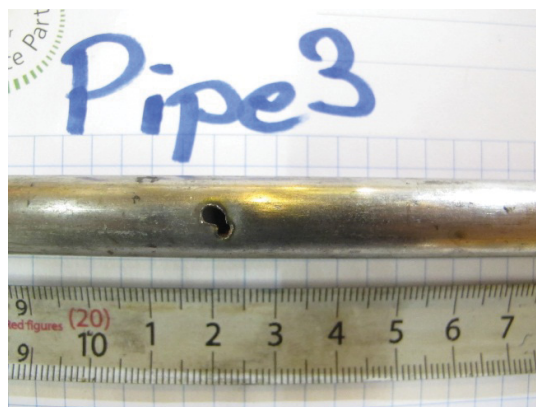
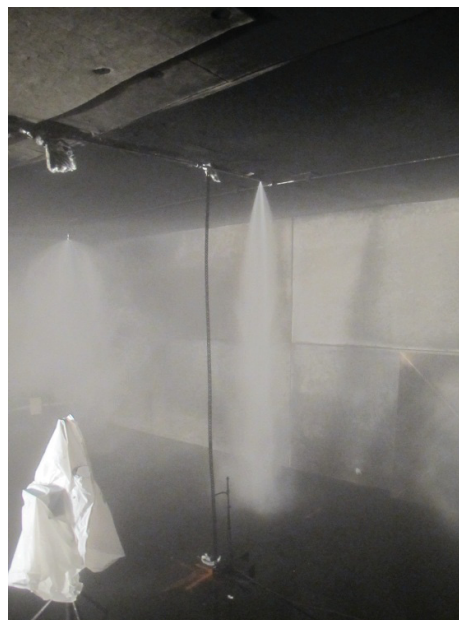
Figure 64. Picture of pipe 3, puncture is approx. 5×2 mm. To the right is a picture of the spray from the punctures when the pipe is installed in the test compartment. The pipe diameter is 12 mm.

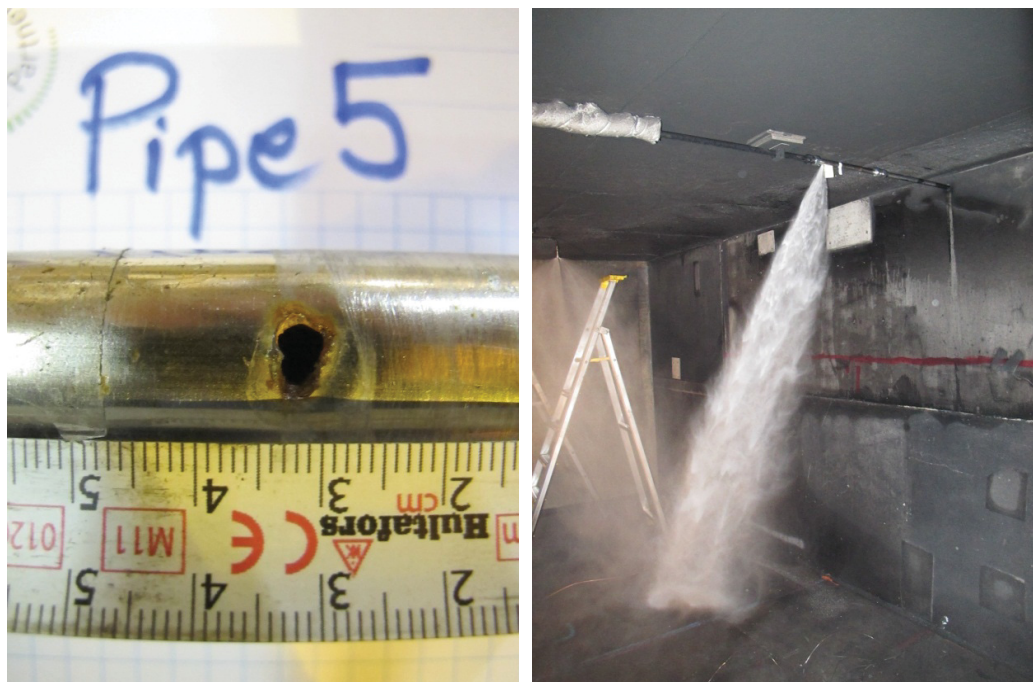
Figure 65. Picture of pipe 5, one puncture approx. 4×5 mm and one buckle approx. 5 mm. To the right is a picture of the spray from the punctures when the pipe is installed in the test compartment. The pipe diameter is 22 mm

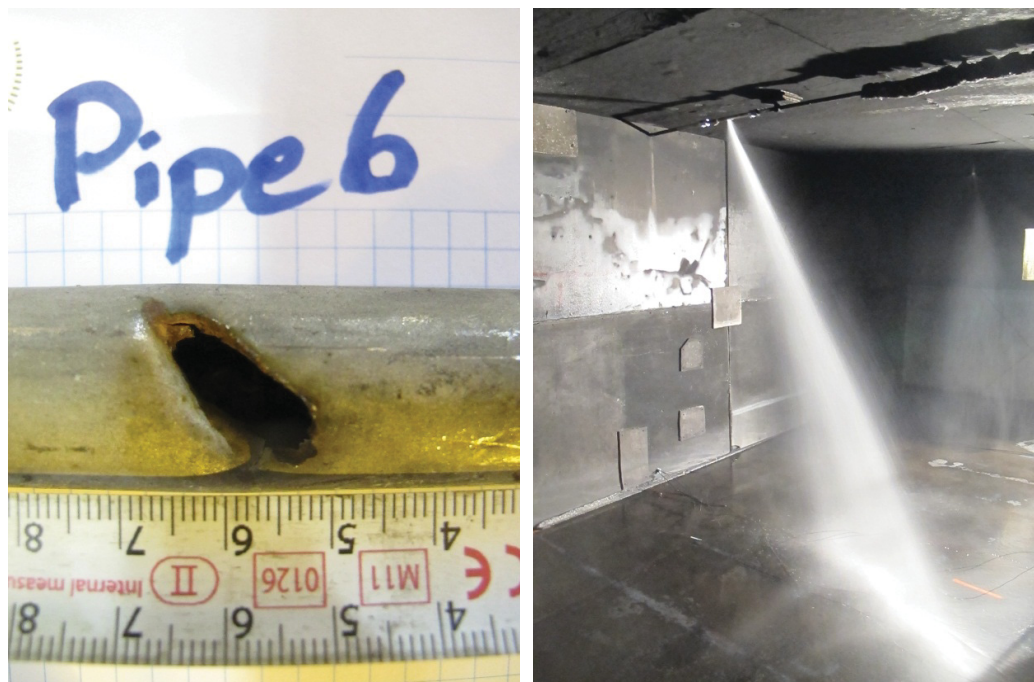
Figure 66. Picture of pipe 6, puncture approx.  $16 \times 6$  mm. To the right is a picture of the spray from the punctures when the pipe is installed in the test compartment. The pipe diameter is 22 mm

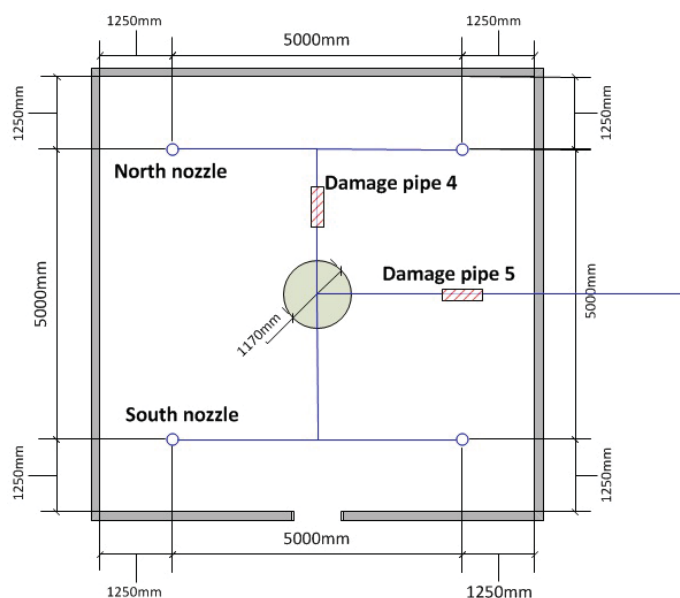
Figure 67. Overview of the test compartment with damage pipe 4 and 5 installed in the piping.

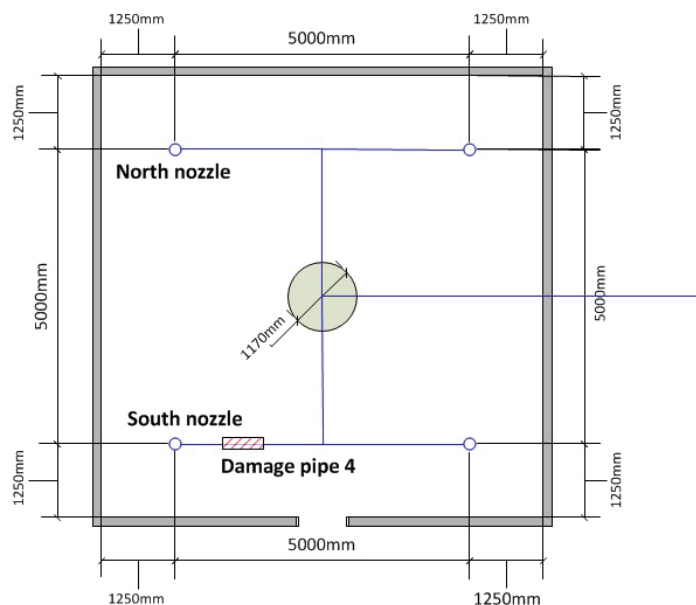
Figure 68. Overview of the test compartment when damage pipe 4 was moved to a different location in the piping.
